# LATERAL MOVEMENT OF PILE GROUP DUE TO EXCAVATION AND CONSTRUCTION LOADS (Case study)

*Abstract: This paper presents a numerical method for analyzing the behavior of pile groups under construction of installing piles and excavating conditions. The numerical modeling and the measured data from construction sites were used for analysis. In the case study, the results of the lateral movement of piles from numerical analyses are in good agreement with the measured data, with differences of around 7.2% and 1.6%. Each incidence and whole construction process were modeled to determine the effects of excavation and equipment loadings for installing piles on the lateral movement of piles and surrounding soil. With the improper construction procedures, the piles can be easily damaged during construction. To mitigate pile damages due to construction, a proposed construction procedure is presented in this study and recommended for use. With the proposed procedure, the lateral movement of pile groups can be greatly reduced by at least 80% and the pile damages will be eliminated.*

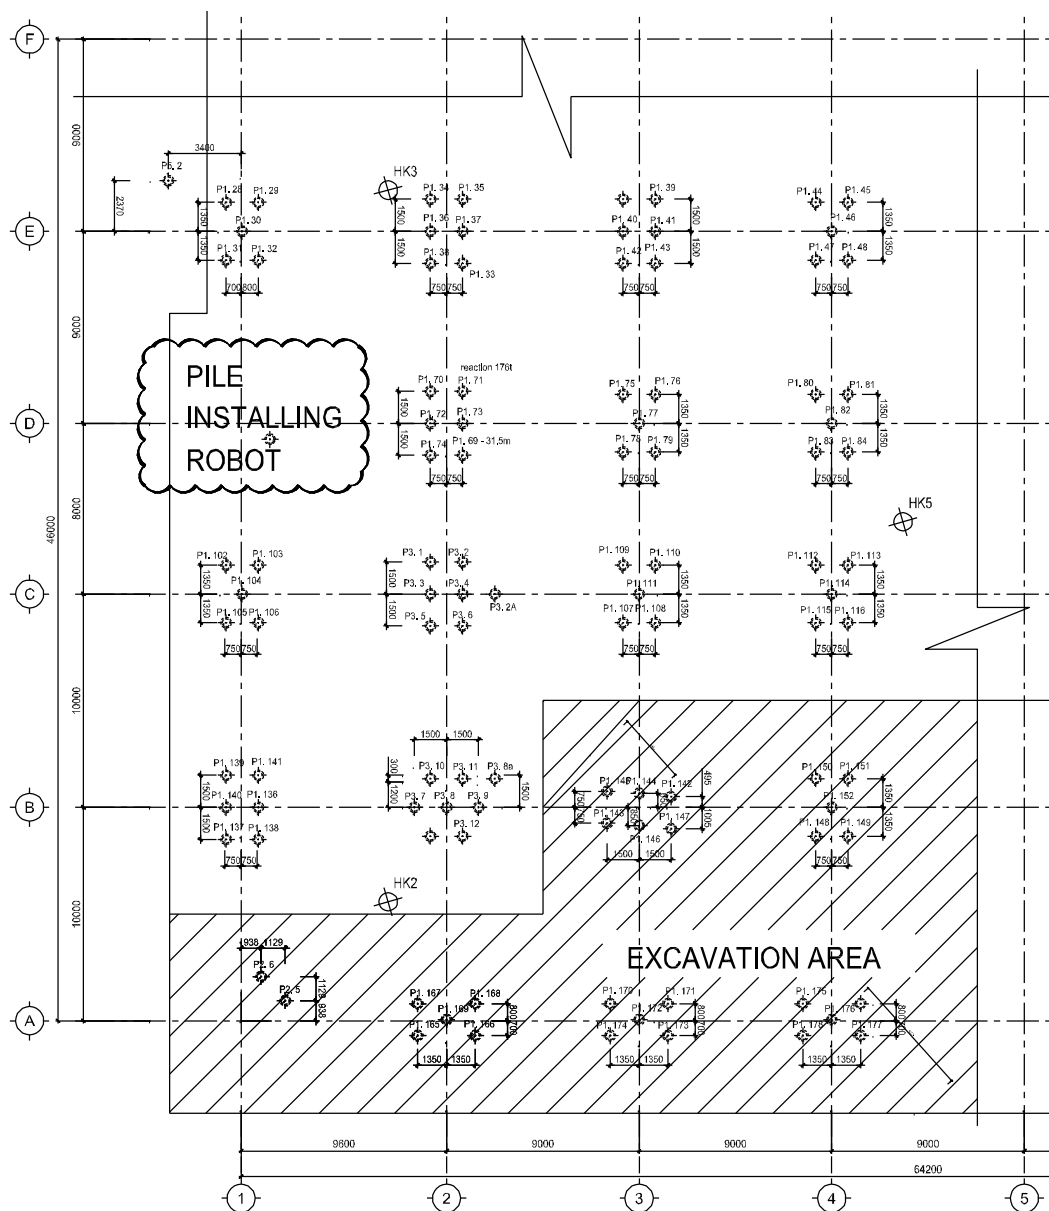
**Figure 4. Pile Distribution and Excavation Location on February 13-14<sup>th</sup> 2020 during pile installation at group 1D**

- On February 13-14, 2020, installation equipment was placed in area 1D. The settlement was very large and we could not install driven piles in this group, so an alternative solution of using bored pile was chosen.

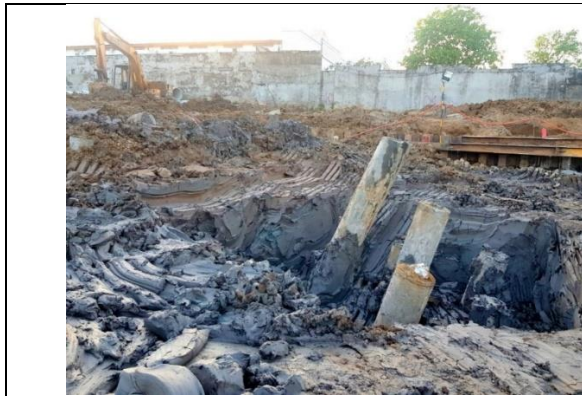
On February 12<sup>nd</sup> 2020 while excavating area 2B, the large lateral movement of piles was discovered, especially at 2B and 2C. The differential level between the bottom of excavation at axis A and the ground level at 1D was about 4 m, it may be a major cause of large lateral pile and soil movement (see Figures 5 and 6).

**Figure 5.** Pile movement at axis A during Excavation

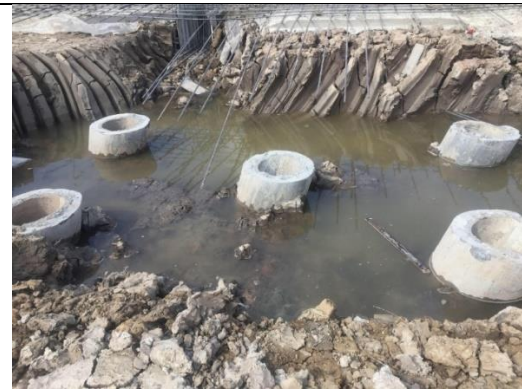
**Figure 6.** Pile movement at axis A during Excavation and construction of pile cap

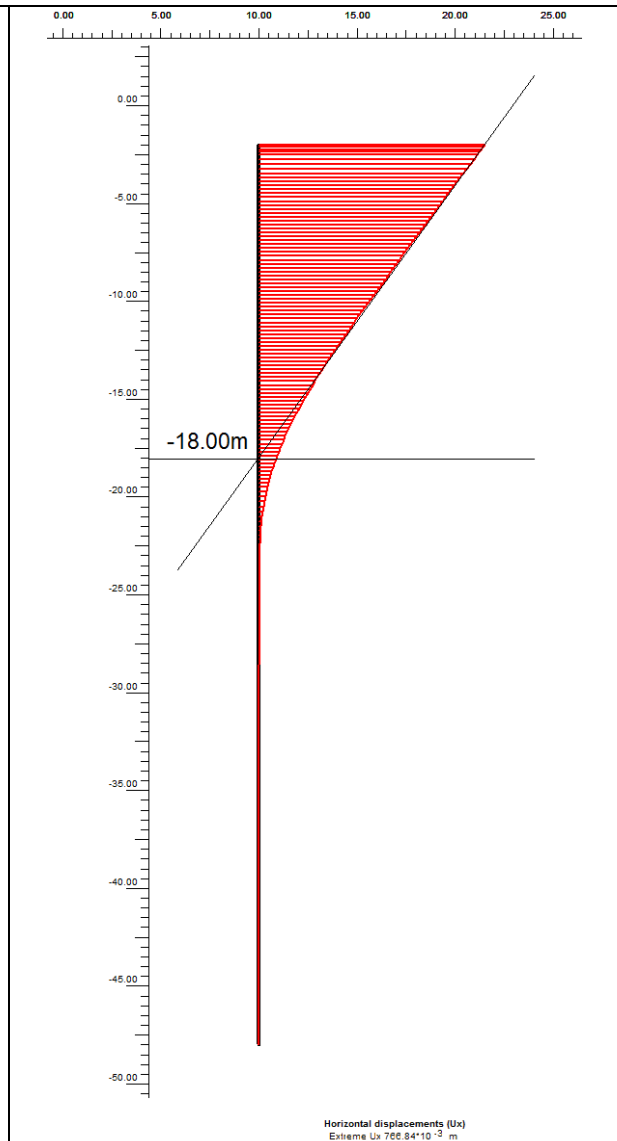
**Figure 10.** Maximum lateral movement of pile in group B ( $U_{xmax} = 76,7cm$ )

Note that the piles shown are broken in Plaxis when reaching the maximum material strength (bending moment or shear) due to the large lateral movement.

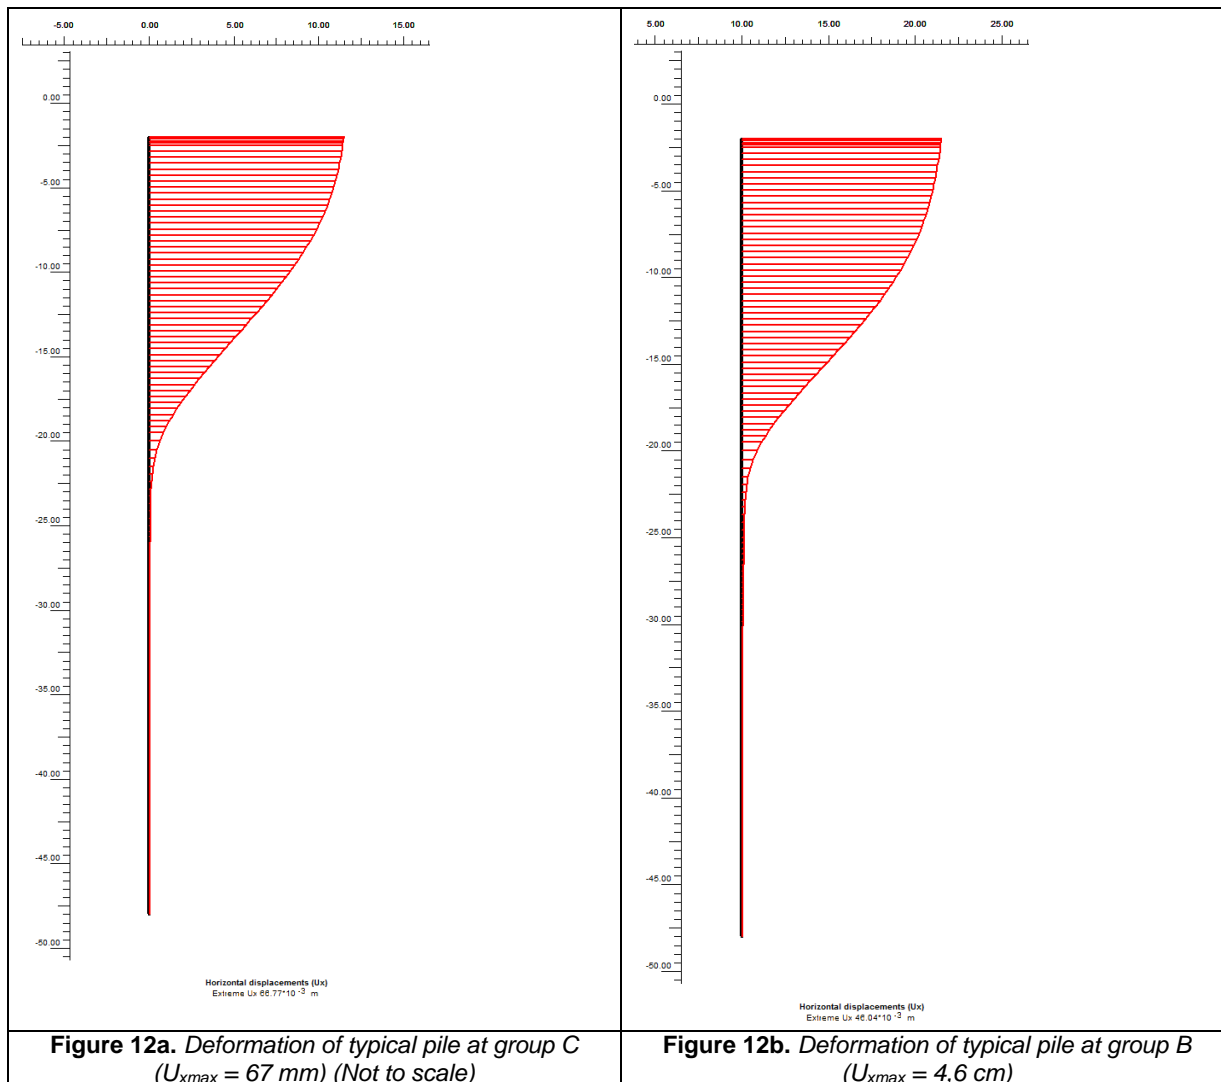
The numerical results show that the maximum lateral movement deformation of the pile head at groups 2B and 2C are 46 mm and 67 mm, correspondingly. The deformation is acceptable, and this value is about 10% of the maximum

movement of the pile heads (462mm and 1822mm). This is due to both the effects of the pile installing equipment load and the excavation. It also shows the importance of the construction procedures.
