## FORECASTING THE RISK OF FLOODING WHEN THE PAC CAP HYDROPOWER DAM BREAKS ON NA RI RIVER IN BAC KAN PROVINCE

### ABSTRACT

Pac Cap hydropower was approved investment policy in Decision No.96/QĐ-UBND dated 18/01/2018 on Na Ri River, Na Ri district, Bac Kan province with the capacity of 6MW. During the construction and operation of 02 units, dam breakdown can occur when the crests of dams, horizontal cracking and cracking along the dam, sliding roof upstream and downstream of the dam, etc. This study focused on simulation of breakage occurrence using the Mike Flood model. The results show that the largest flood depth would be over 10 meters with the flooded area of about 15 hectares, which is mainly land for annual crops, rice land and production forests; depth from 4 to 10 meters would occupy about 10 hectares; depth of 1 to 4 meters in addition to the forest land and inundated agricultural land would engulf about 30 houses in Luong Thanh and Lam Son communes of Na Ri district and some other infrastructure projects. The results of the study are the basis for introducing preventive measures to minimize the damage to the downstream area, as well as to determine the responsibility of

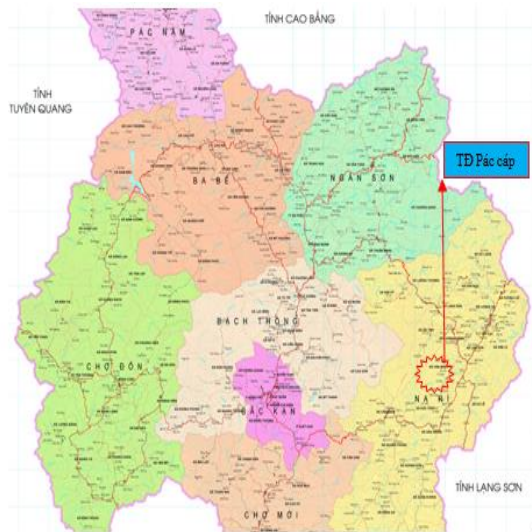
**Figure 1.** Pac Cap Hydropower plant position

In 2010, Bac Kan People's Committee approved Decision No 2461/QĐ-UBND about Planning of medium and small hydropower plants. Pac Cap hydropower plant was in the list of plants with good economic parameters: 3.2 MW capacity, total power output  $E_o = 13.18$  million kWh, mND = 323m on Na Ri river, Luong Thanh commune, Na Ri district (Figure 1). However, in 2018, the area was surveyed, recalculated and updated with new technologies with the new capacity of 6MW and Bac Kan People's Committee approved the investment plan at Decision No 96/QĐ-UBND on 18/01/2018. The main parameters are as follow: MND = 246.5m, MNC = 245.5m, annually average output  $E_o = 21.26$  mil kWh. Coordinate:  $22^{\circ}12'38''$  N,  $106^{\circ}07'48''$  E,  $F_{IV} = 540$  km<sup>2</sup>.

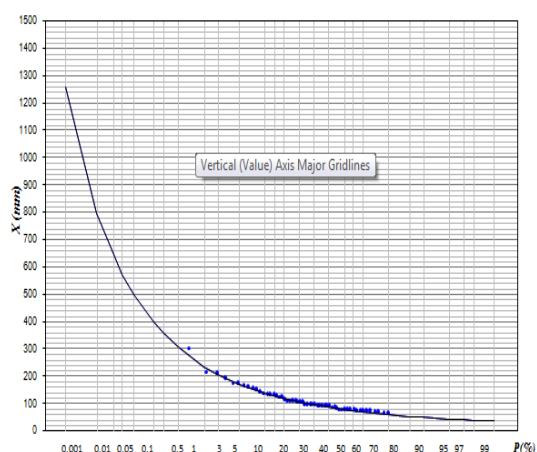
**Figure 5.** Frequency line of the heaviest 1 day rain at Bac Kan station

- Map of the area on a scale of 1/2000.
- Na Ri river horizontal cut section.
- Data on daily, monthly, yearly amount of rainfall at the dam area (Figure 5,6).
- Relation between  $H \sim Q$  at Thac Gieng hydro station (Figure 2).
- Data on the frequency line of yearly water

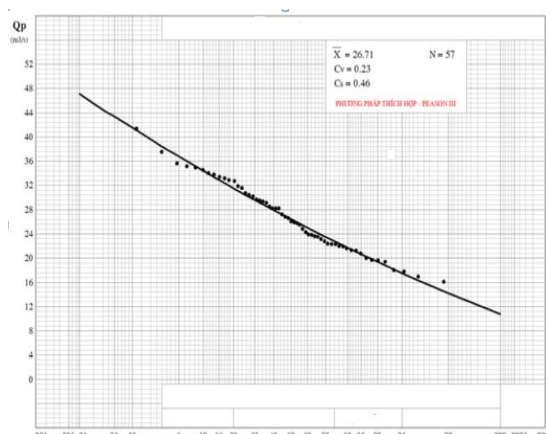
**Figure 6.** Frequency line of yearly water flow at Pac Cap hydropower plant

flow (Figure 6), design and control floods at Pac Cap dam (Figure 3).
